## Response of Partially Covered Road Embankments and its Environmental Impact

**Keywords:** Road Embankments, Surface Cover, Tropical Rainfall, Turbidity, Total Suspended Solids

**Abstract.** Tropical regions have always suffered soil loss by water which deteriorates the surrounding environment in several ways. This paper focuses on one of an issue that under the tropical rainfall event how the newly constructed bare highway affects the water turbidity and total suspended solids in a water channel. The study was based on a pilot scale field test which was constructed in compliance with the real field conditions. The study was limited to the tropical rainfall event of 40 mm/hr, native grass cover, sandy loam, and for the road side slope of 1V:1.5H (~ 30°). To determine the turbidity and total suspended solids (TSS), three plots were observed with the different percentage of covers namely, no cover (plot A-control plot), 50% of the grass covered surface (plot B), and 30% of the grass covered surface (plot C). The purpose of the study was to observe the influence of these three plots on the dependent variables that is turbidity and TSS. The study summarizes that the presence of cov

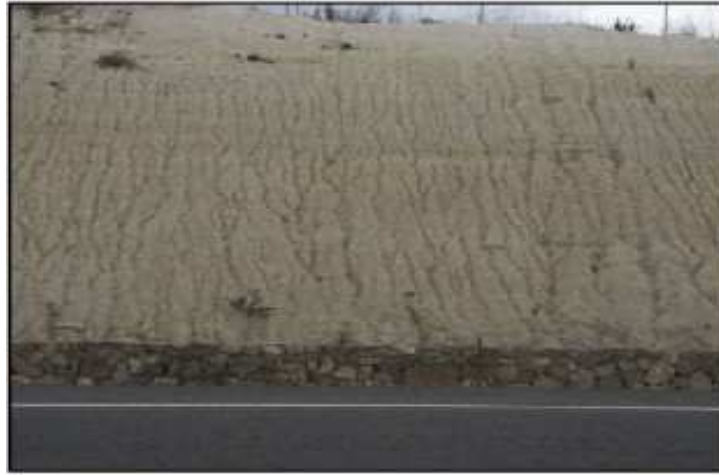
**Figure 1.** Newly constructed embankment [2].

In spite of its limited periphery roads cannot be disregarded while comparing the soil loss with the agricultural activities [1]. The soil loss observed from the exposed embankments is similar to that of observed from the parched lands [2]. By the year 2050, the urban community is expected to reach the globe by 9.5 billion and most of the increment is anticipated in the developing regions like Asia and Africa which are susceptible to water contamination. Roads construction is among the vital source of soil loss which aids the sedimentation process by flowing towards the water channel in the form of surface runoff [3]. Not only the construction activities but the public works, logging activities and agricultural activities are considered equally responsible for the occurrence of soil loss [4]. Road construction induces higher erosion rates as it usually remains bare and uncovered which makes it exposed to the rain drop impact [5] that ultimately influences the natural surrounding [6]. On the contrary, the need of roads is necessary for the economic development of the country [7]. Therefore, to lessen the soil loss phenomenon, immediate surface cover is required to protect the exposed soil surface once the road construction phase is completed [8]. Fig. 1 shows the view of newly constructed bare road embankment affected by the rain drop impact.

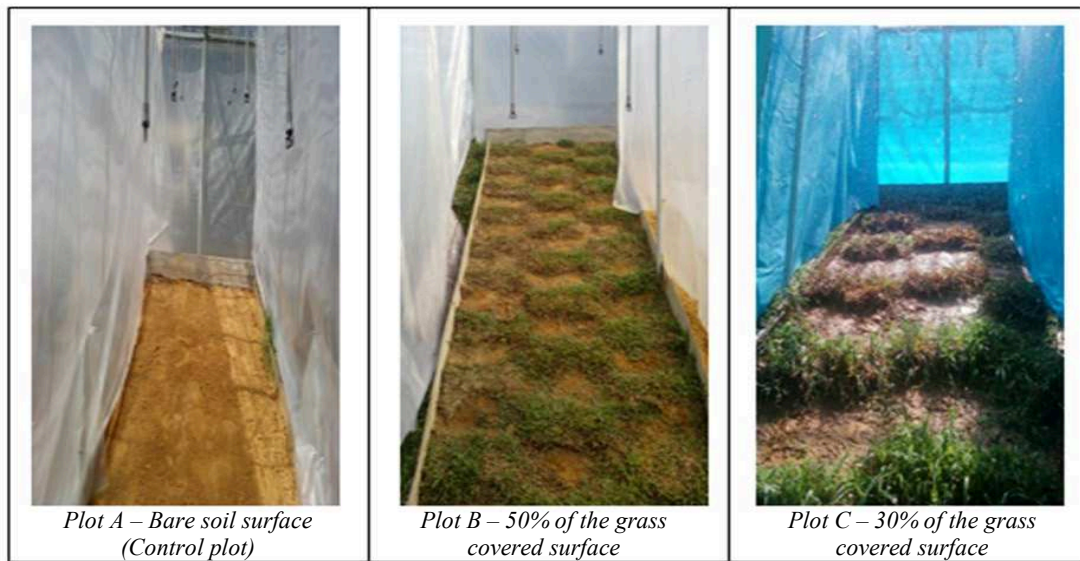
**Figure 2.** Bare soil surface, 50% of the covered surface, and 30% of the covered surface.

The study was conducted at Universiti Teknologi PETRONAS (UTP), Malaysia. A side slope with the gradient of  $\sim 30^\circ$  was observed under the simulated rainfall conditions with the different percentage of land covers. The rainfall intensity opted for the experimental run was 40 mm/hr (the average rainfall event) for which the rainfall data of Perak, Malaysia (2005-2011) was attained and analyzed. Each plot (2 meters length x 6 meters width) was served under the similar simulated rainfall conditions, soil type, and slope inclination for estimating the water turbidity and TSS values from the bare soil surface, 50% of the grass covered surface, and 30% of the grass covered surface. The study area was sheltered by a roof and covered with the plastic so that the plots can be protected in case if the natural rainfall occurs as shown in Fig. 2. The rainfall intensity was adjusted to 40 mm/hr on the flow meter which was kept noticed so that it assures that the rainfall conditions remained constant throughout the experimental phase. A container was placed at the bottom of each plot so that the water samples can be collected after every 15 min for a period two hours. The water samples were collected in the labeled plastic bottles from all the plots so that the samples cannot be
